# PLAY AREA SAFETY INSPECTION REPORT

For Stradbroke Parish Council

On 26<sup>th</sup> June 2020

Play Area, Wilby Road, Stradbroke, Suffolk

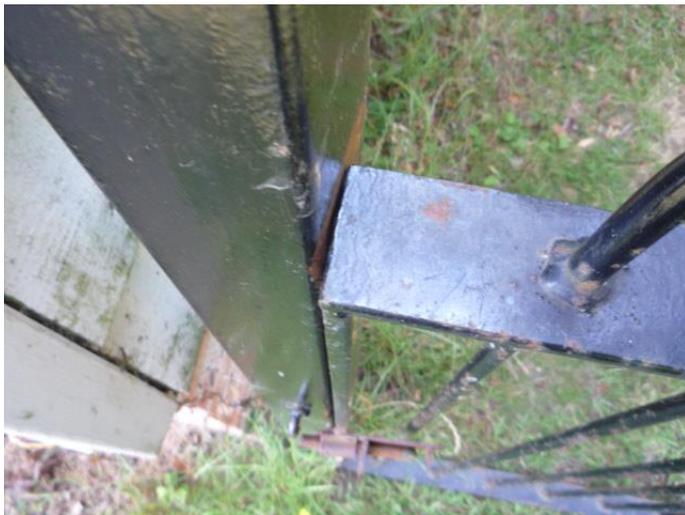
Gate (Rear gate) – Entrapment on the side(s) of gate. Recommend to adjust gate/post/fit new rubber buffer to ensure a spacing of at least 12mm throughout the range of the gate to remove the finger entrapment. The 12mm gap should also apply on the hinge side of the gate – Low risk.

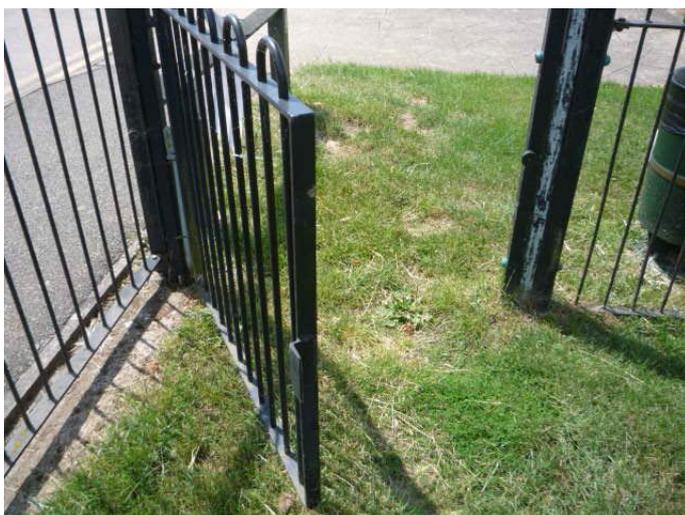
Main Pedestrian Self Closer Gate – The gates closing mechanism does not work correctly and the gate does not close properly. Recommend work to allow gate to self close. Ideally gate from open should not close in less than 5 seconds. Area is not now dog proof.

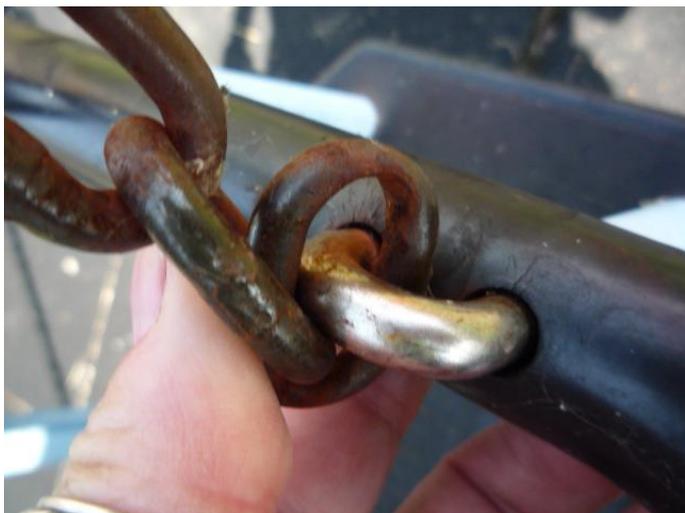
Some chain wear. Recommend Monitor for further deterioration and replace at 40% wear.

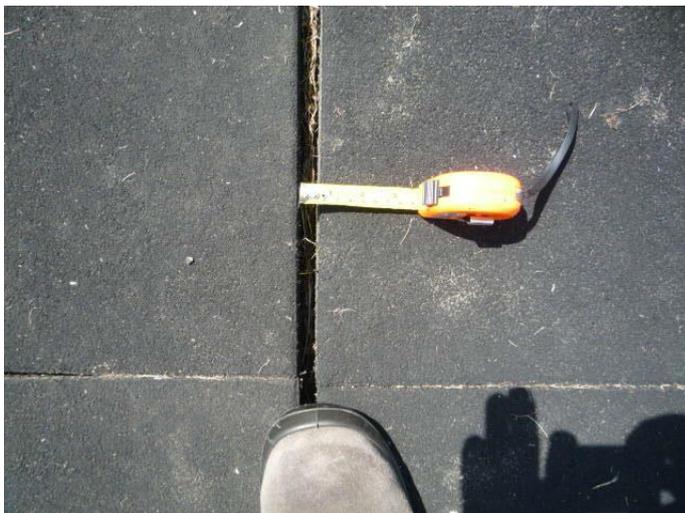
Surface is lifting. Recommend re-glue and fill gaps and joints as necessary (gaps 10-15mm ) – Low risk.

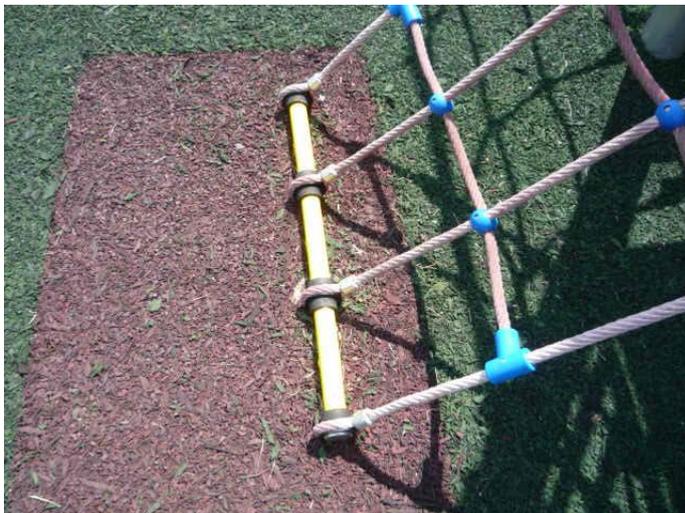
Hard object in fall area - Metal bar at bottom of Net – Recommend monitor only - Low risk.

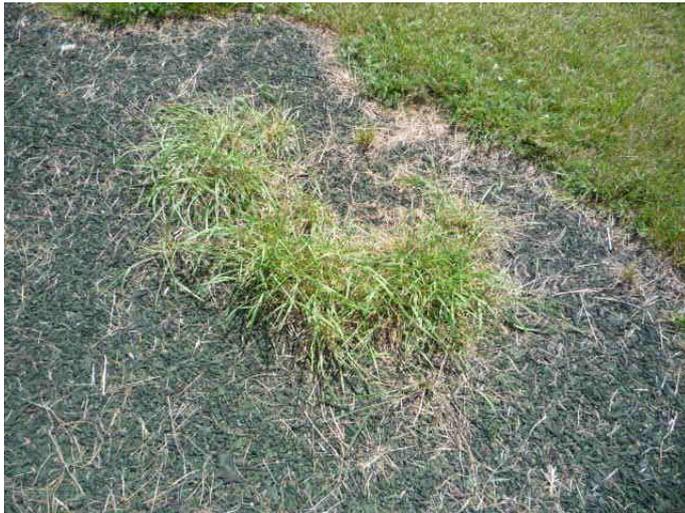
Recommend remove weed growth and treat with appropriate non-toxic or non-residual sprays (as weeds may damage surface) – Low risk.

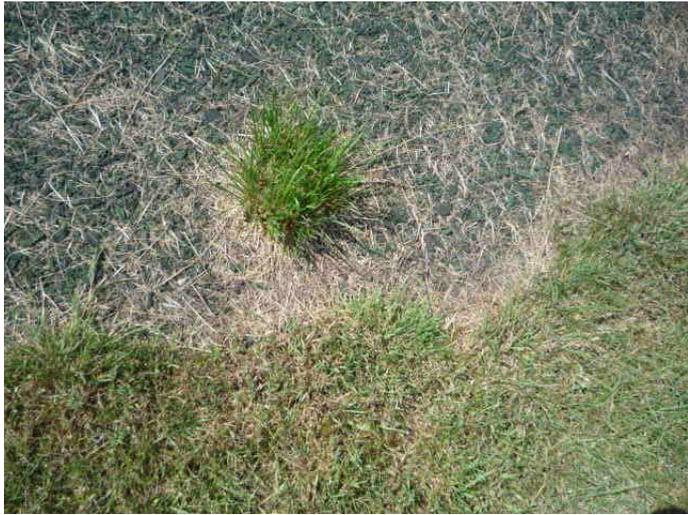
Recommend remove weed growth and treat with appropriate non-toxic or non-residual sprays (as weeds may damage surface) – Low risk.

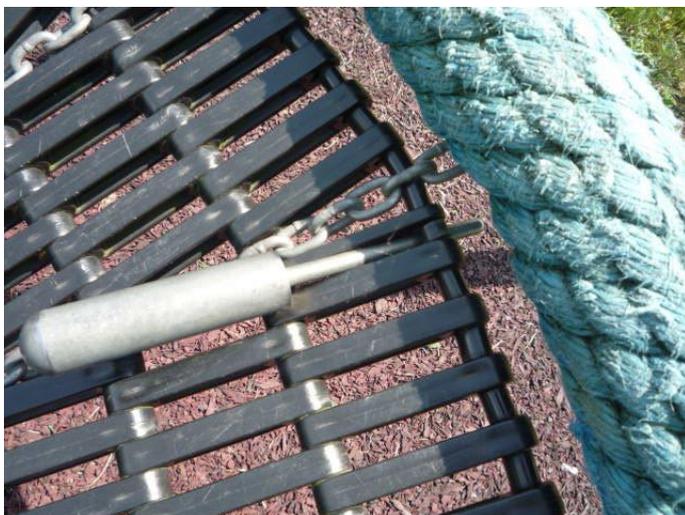
Finger entrapments in plastic fixings on basket – Monitor only – Low risk.

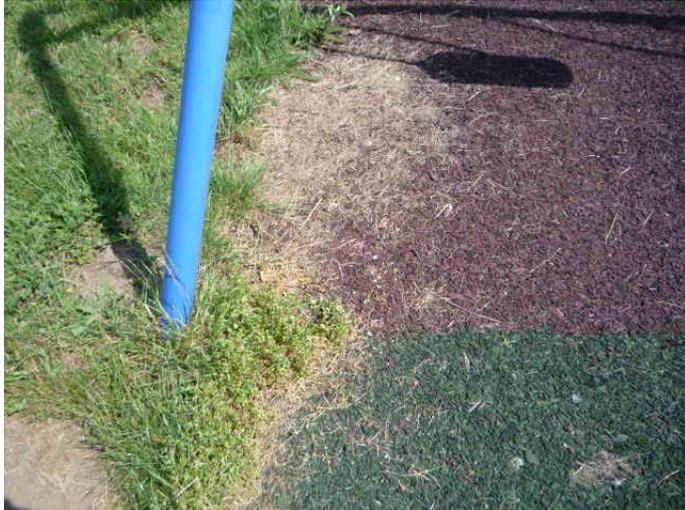
Recommend remove weed growth and treat with appropriate non-toxic or non-residual sprays (as weeds may damage surface) – Low risk.

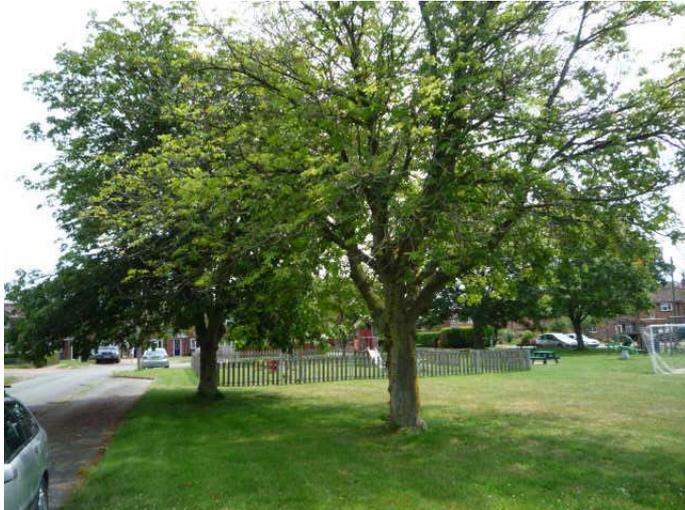
Mature trees in play area – Recommend to inspect annually by qualified arboriculturist and to remove any dead, diseased and damaged wood.

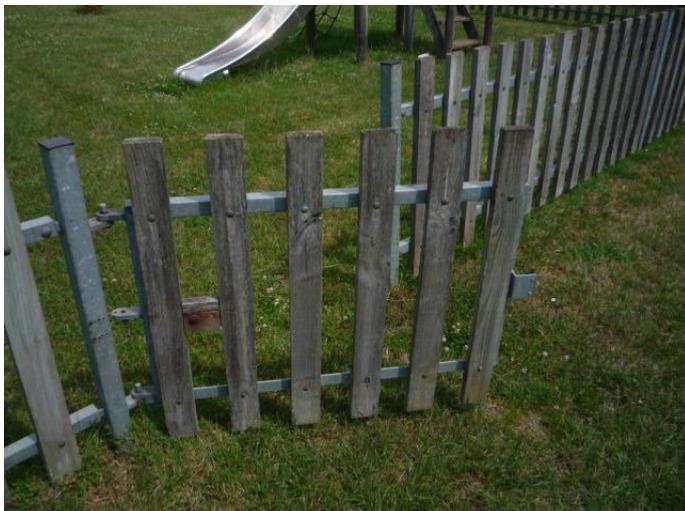
Gates x 2 – Recommend self closer mechanism are fitted. Play area is not dog proof.

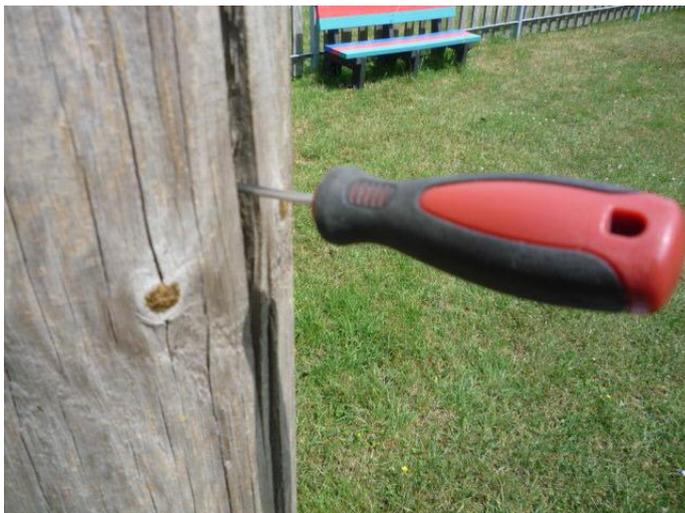
Recommend monitor cracks in support timbers (8mm wide and 50mm deep) Replace when 12mm gaps are found - Low risk.

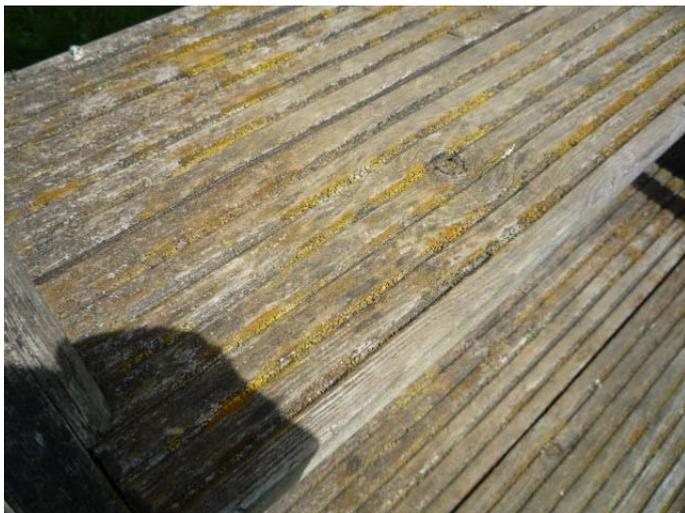
Recommend remove algae off steps, which may be slippery when wet - Low risk.

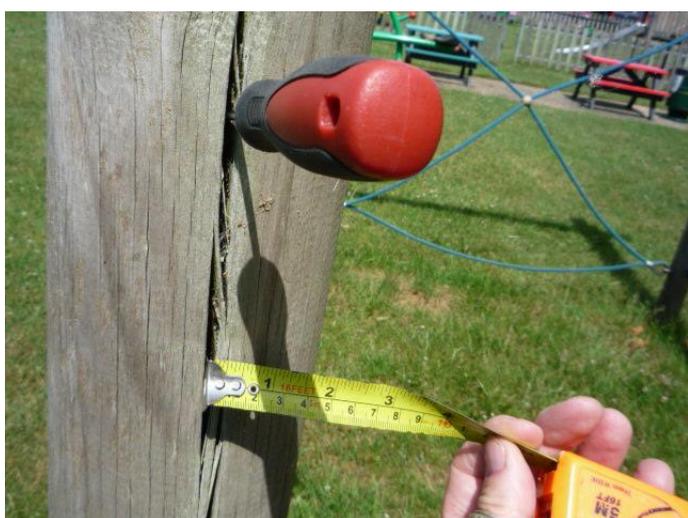
Recommend Monitor cracks to support posts – (4mm wide gaps and 40mm deep) - Low risk.

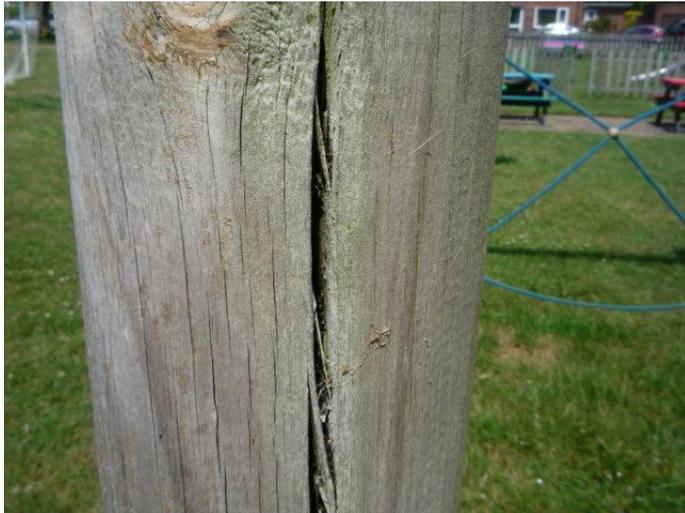
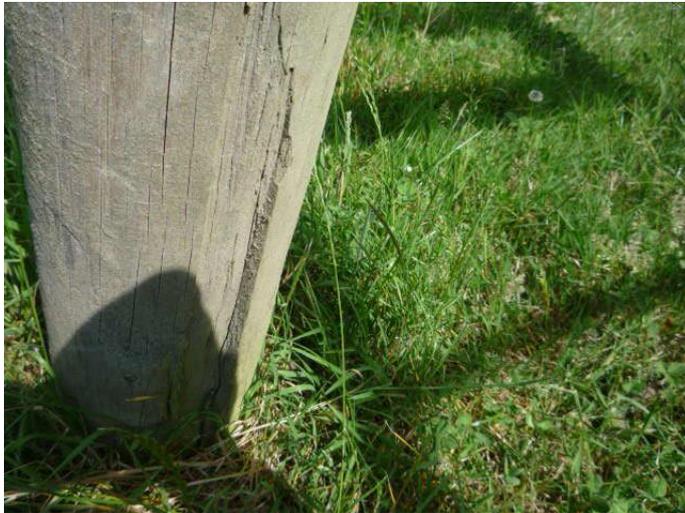
Recommend smooth down damaged areas – Low risk.

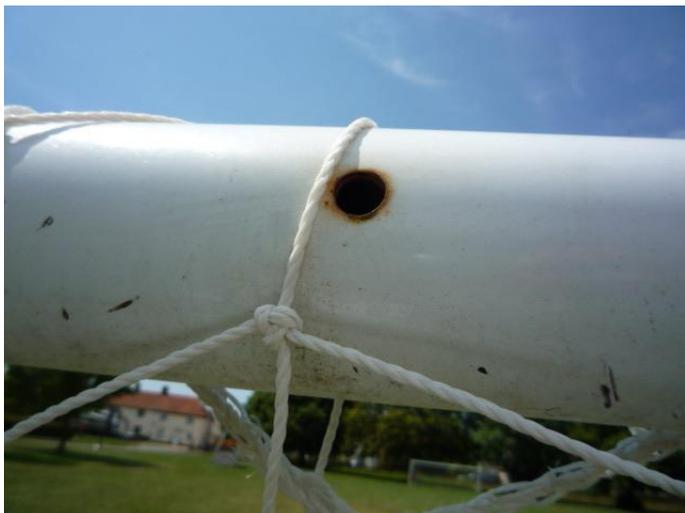
Recommend infill holes in posts and cross bars to eliminate finger entrapments – Low risk.

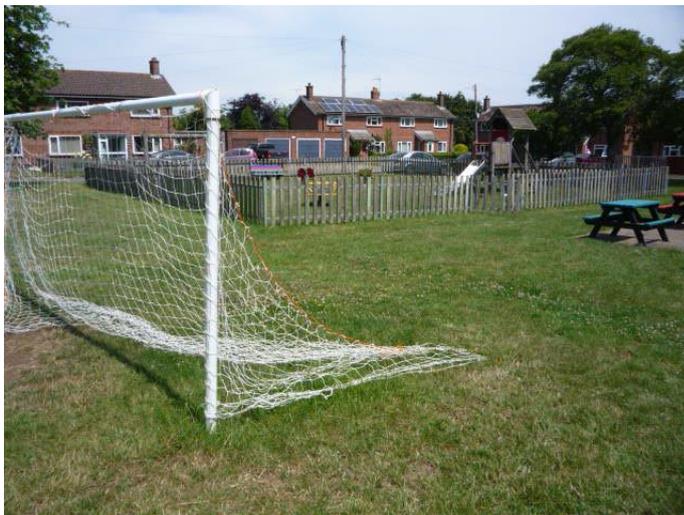
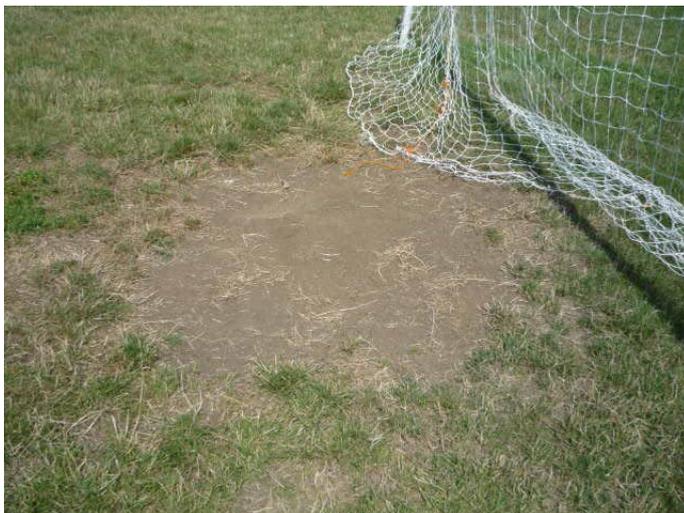
Recommend move goal forward 10 metres to avoid worn area and move further away from play items – Low risk.

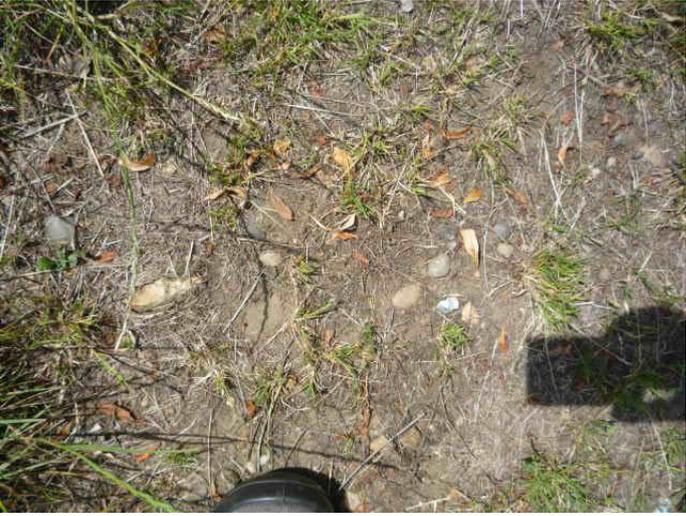
Recommend remove exposed stones (goal at main road end) – Low to Medium risk.

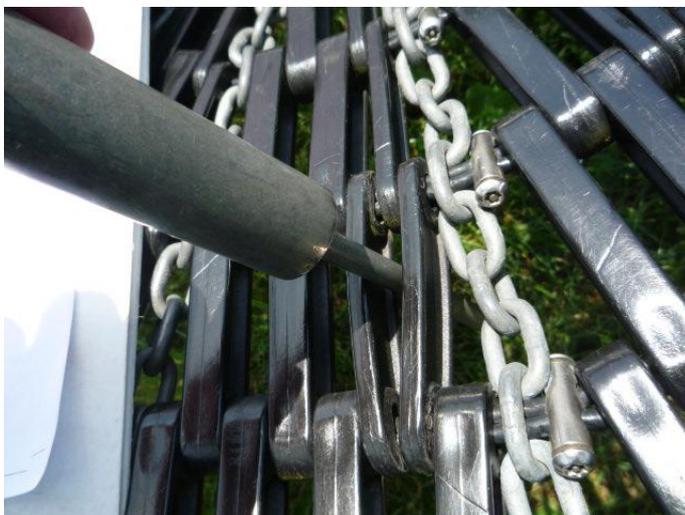
Finger entrapments in plastic fixings - Recommend Monitor - Low risk.
