# PLAY AREA SAFETY INSPECTION REPORT

For Stradbroke Parish Council

On 26<sup>th</sup> June 2020

Play Area, Wilby Road, Stradbroke, Suffolk

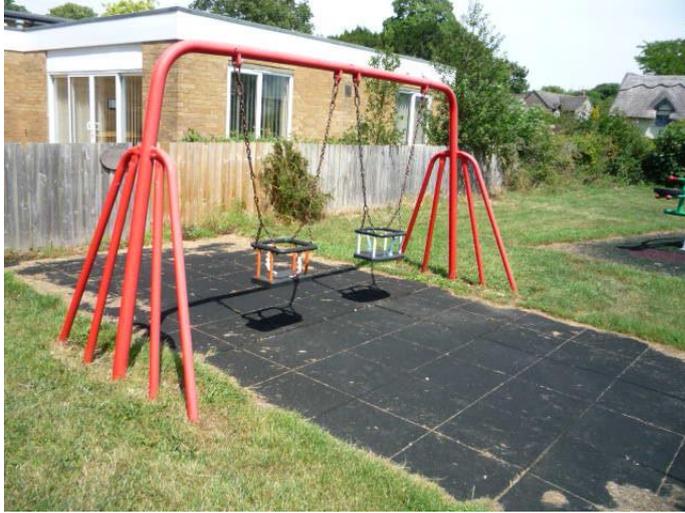
**Item: 1 Bay 2 Cradle seat Swing (1850mm) – Wicksteed Leisure**

The item meets the requirements of EN1176 where this may be tested on site without dismantling or destruction.

Surface is lifting. Recommend re-glue and fill gaps and joints as necessary (gaps 10-15mm ) – Low risk.

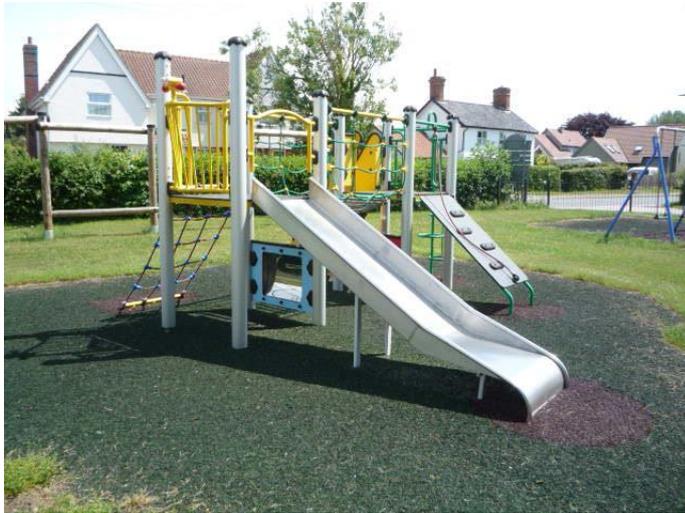
**Item: 'Playzone - Pole Up and Down' - Sutcliffe**

The item fails to meet the requirements of EN1176 in the following respects:

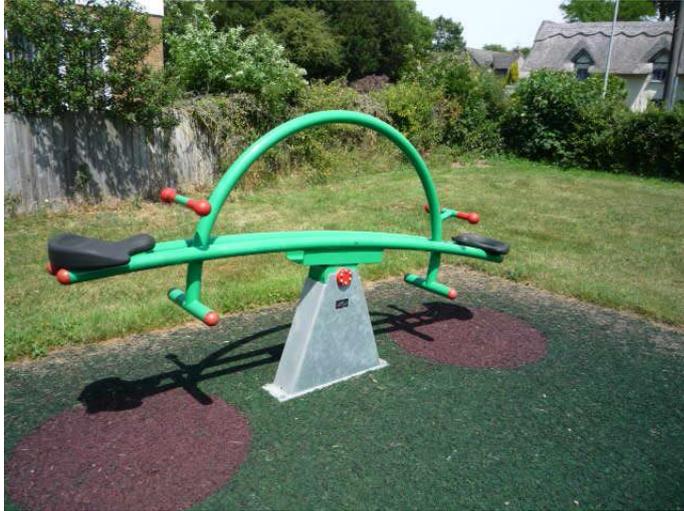
**Item: Type 1 Rocker - Seesaw - Sutcliffe**

The item meets the requirements of EN1176 where this may be tested on site without dismantling or destruction.

The surfacing is in a satisfactory condition and no work is required at this time.

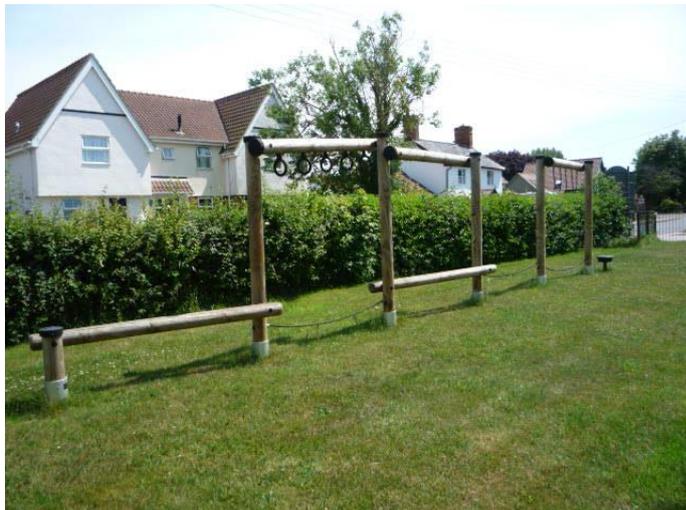
## **Item: Adventure Trail (Linked – 6 challenges)- Sutcliffe**

The item meets the requirements of EN1176 where this may be tested on site without dismantling or destruction.

The surfacing is in a satisfactory condition and no work is required at this time.

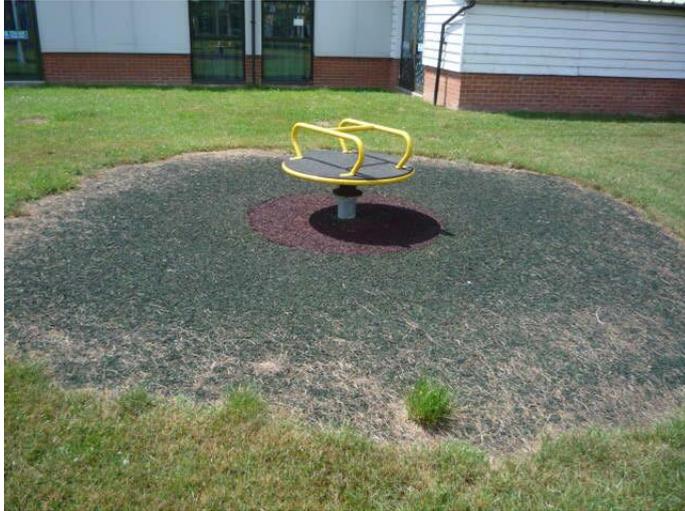
## **Item: Roundabout - Sutcliffe**

The item meets the requirements of EN1176 where this may be tested on site without dismantling or destruction.

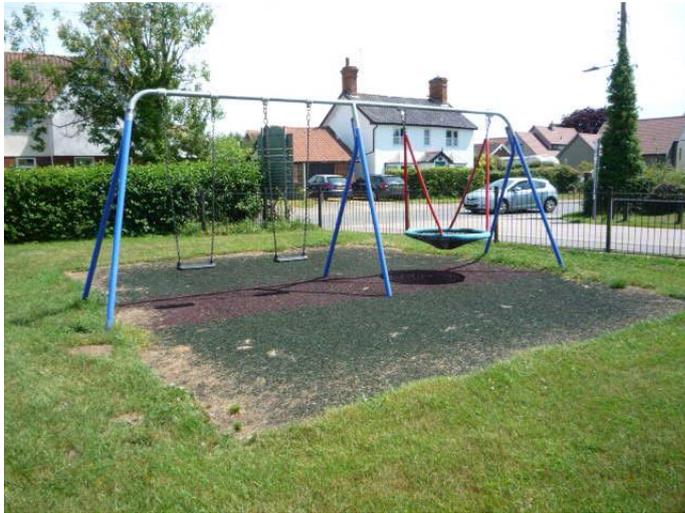
**Item: 2 Bay 1 Basket / 2 Flat Seat Swing - Sutcliffe**

The item fails to meet the requirements of EN1176 in the following respects:

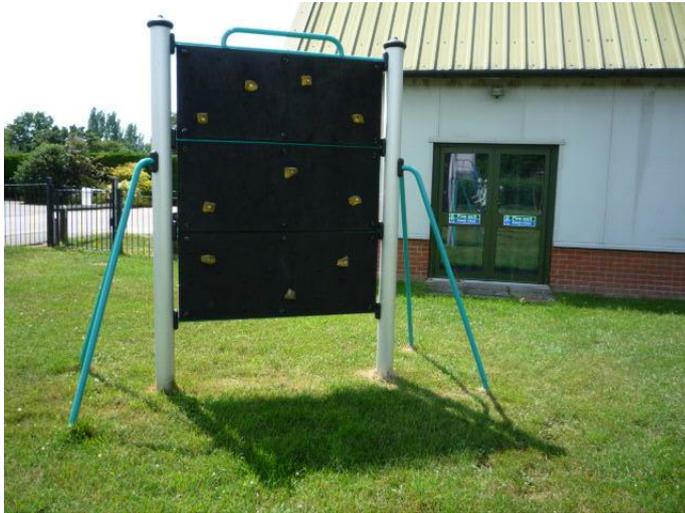
**Item: Climbing Wall - Sutcliffe**

The item meets the requirements of EN1176 where this may be tested on site without dismantling or destruction.

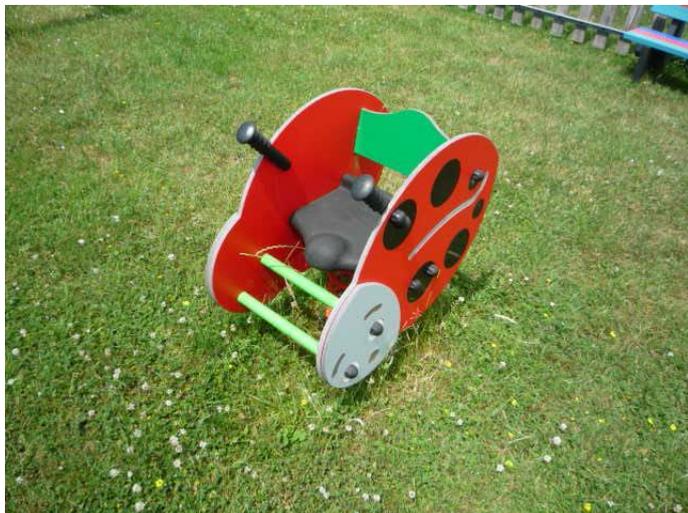
### **Item: Type 2a Rocker - Ladybird Springy - Sutcliffe**

The item meets the requirements of EN1176 where this may be tested on site without dismantling or destruction.

The surfacing is in satisfactory condition and no work is required at this time.

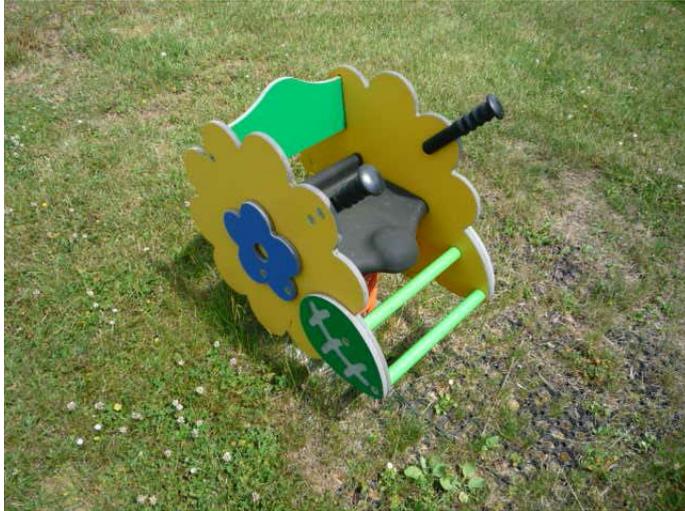
**Item: Type 2a Rocker - Springy Flower - Sutcliffe**

The item meets the requirements of EN1176 where this may be tested on site without dismantling or destruction.

The surfacing is in satisfactory condition and no work is required at this time.

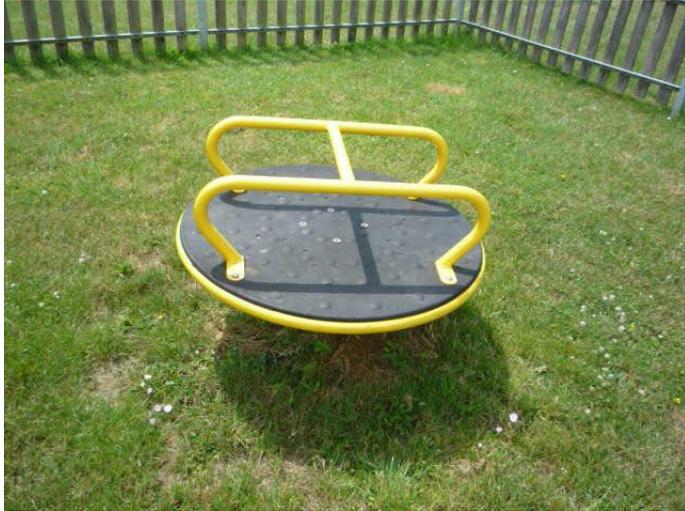
**Item: Roundabout - Sutcliffe**

The item meets the requirements of EN1176 where this may be tested on site without dismantling or destruction.

The surfacing is in satisfactory condition and no work is required at this time.

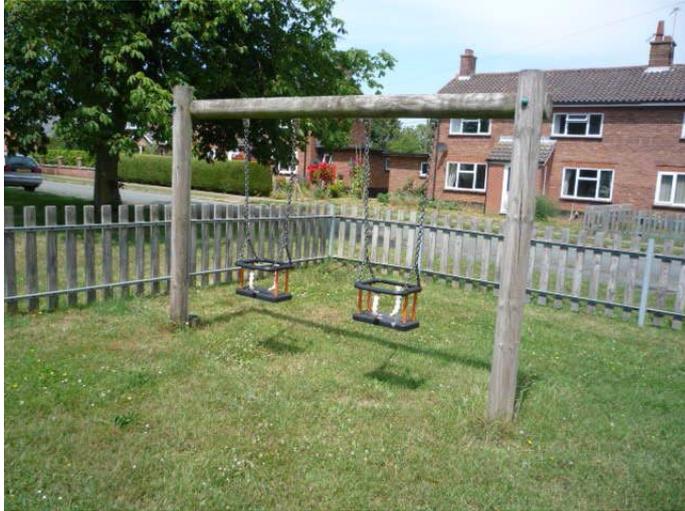
## **Item: 1 Bay 2 Cradle seat Swing (1900mm) – Adventure Play**

The item meets the requirements of EN1176 where this may be tested on site without dismantling or destruction.

The surfacing is in satisfactory condition and no work is required at this time.

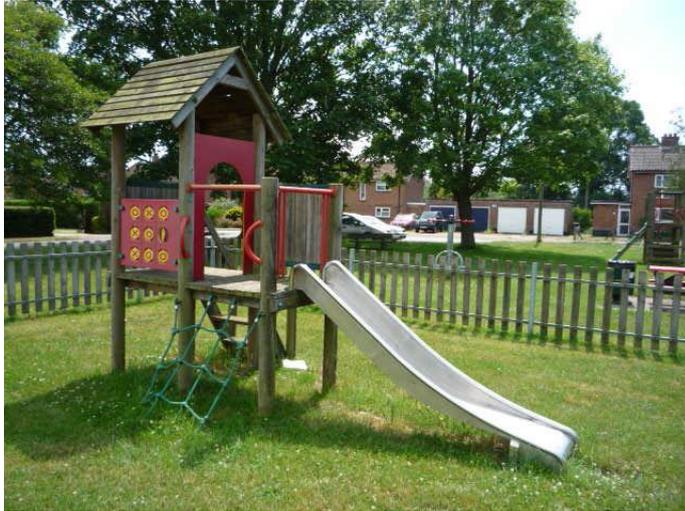
## **Item: Waxham 1 – Adventure Play**

The item meets the requirements of EN1176 where this may be tested on site without dismantling or destruction.

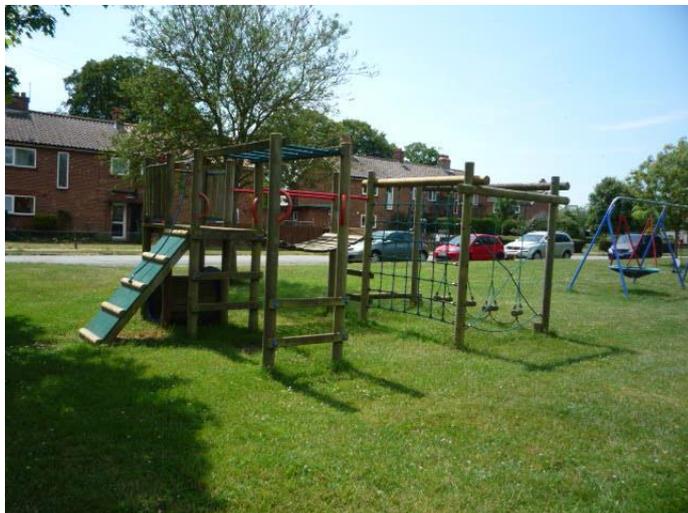
### Item: Lavenham 1 – Adventure Play

The item meets the requirements of EN1176 where this may be tested on site without dismantling or destruction.

The surfacing is in satisfactory condition and no work is required at this time.

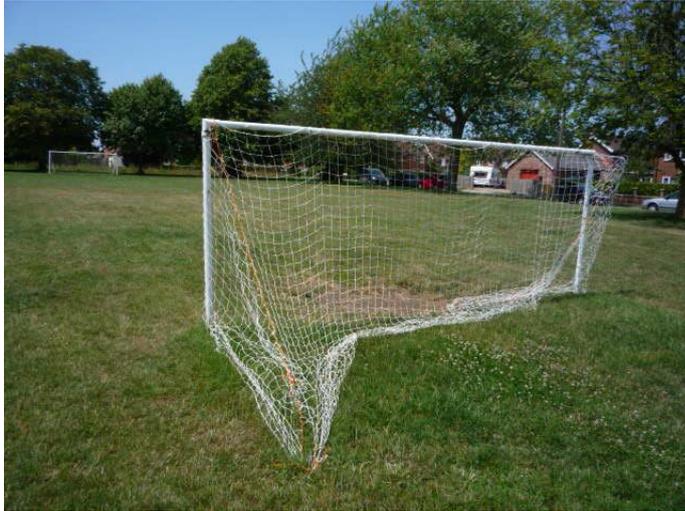
## **Item: 2 Small size Goals - Harrod**

The item meets the requirements of EN748 where this may be tested on site without dismantling or destruction.

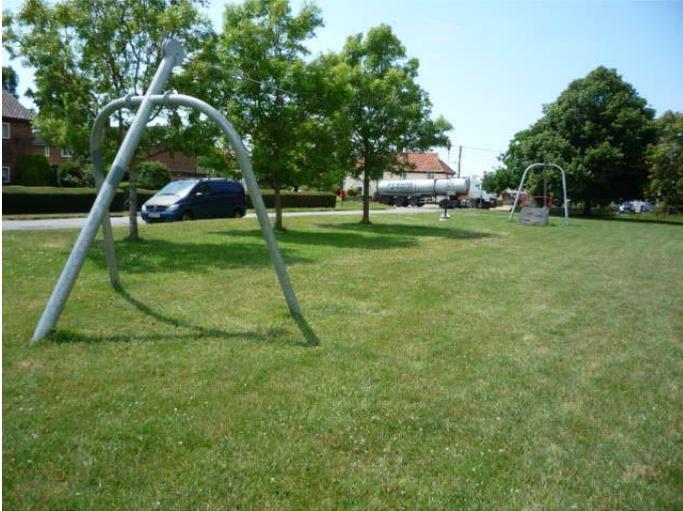
## **Item: Cableway - Sutcliffe**

The item meets the requirements of EN1176 where this may be tested on site without dismantling or destruction.

The surfacing is in satisfactory condition and no work is required at this time.

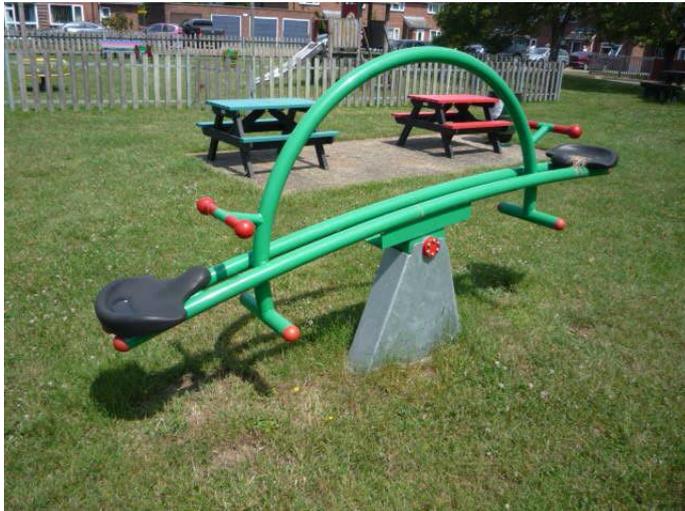
**Item: Type 1 Rocker - Seesaw - Sutcliffe**

The item meets the requirements of EN1176 where this may be tested on site without dismantling or destruction.

The surfacing is in satisfactory condition and no work is required at this time.

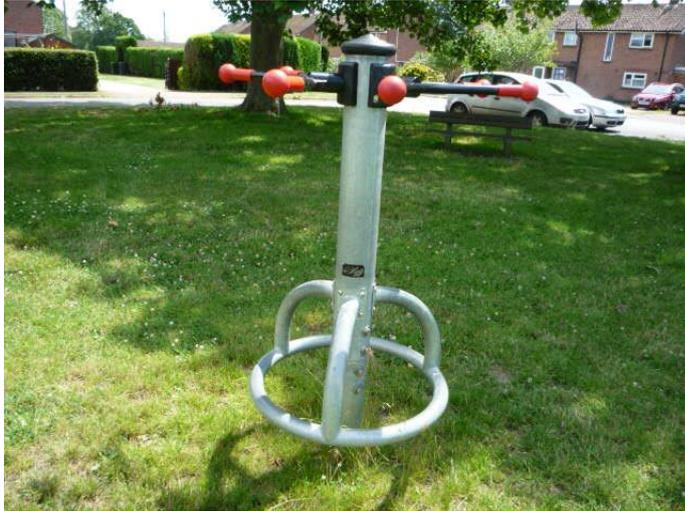
## **Item: Rota - Sutcliffe**

The item meets the requirements of EN1176 where this may be tested on site without dismantling or destruction.

The surfacing is in satisfactory condition and no work is required at this time.

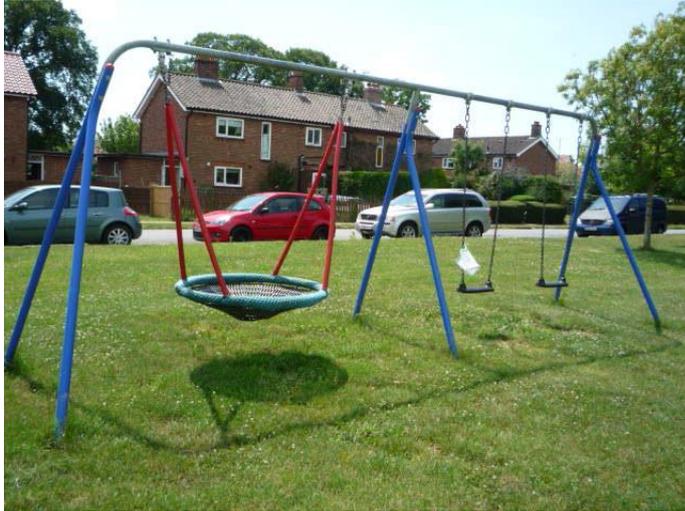
**Item: 2 Bay 1 Basket / 2 Flat Saet Swing (2300mm) - Sutcliffe**

The item fails to meet the requirements of EN1176 in the following respects:
